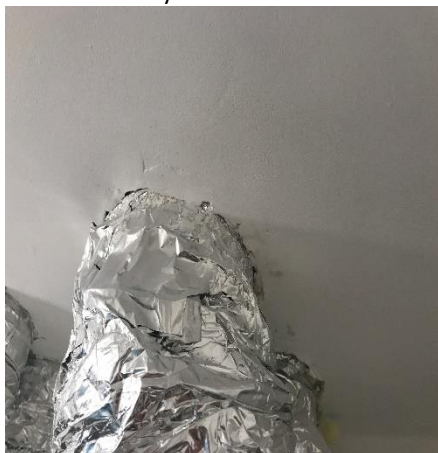
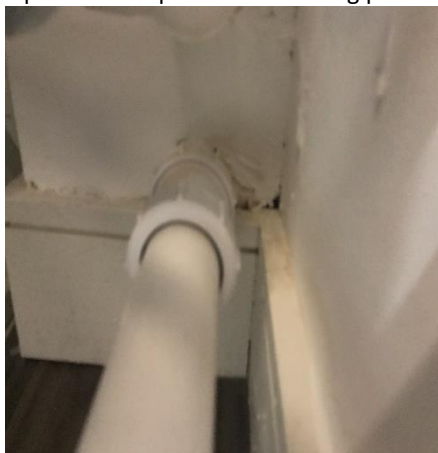
- Pencil marks on walls still around and above pipes.
- Poor finish around plumbing behind washing machine.
- Oxidation on piping already; consider reason and longevity implications.

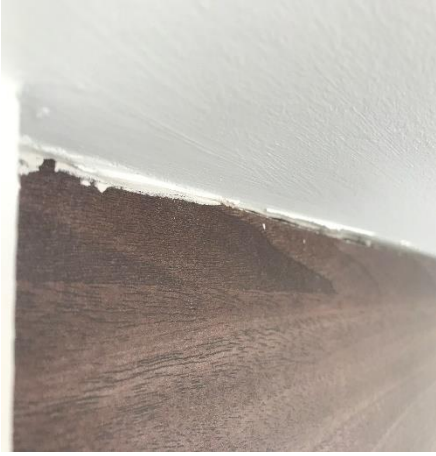
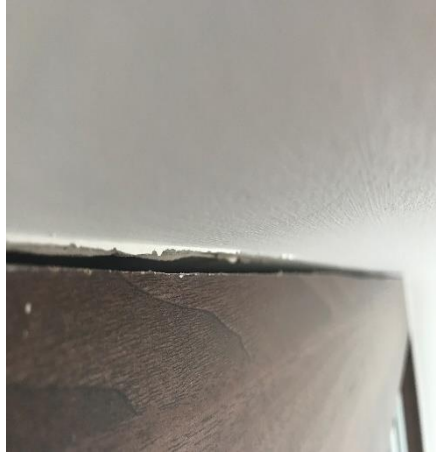
- Caulk and paint flicks in built in wardrobe woodwork and open junction between ceiling and built in wardrobe woodwork.

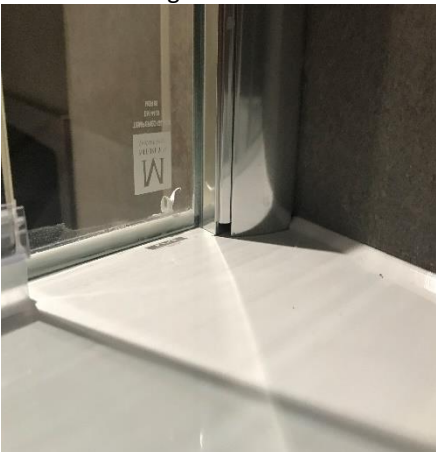
- Loose shower controls (rattle) and no seals between shower control chrome panels and the tiled walls.

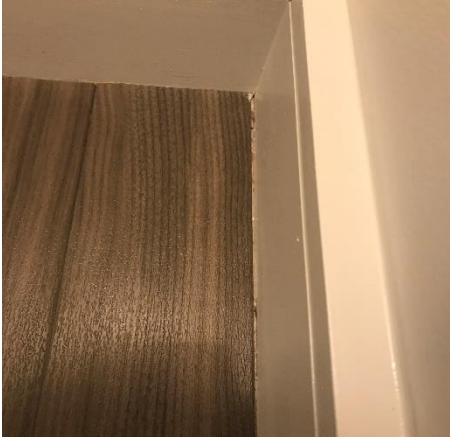
- Paint on sensor plastic.
- Poor prep work to walls prior to painting observed around the door architrave.
- 3mm gap between floor and skirting open along right hand elevation.

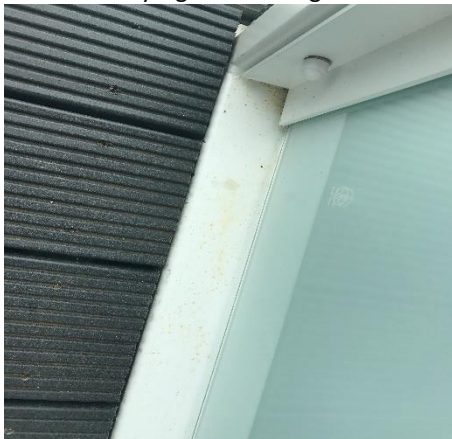
- Paint on door framework.

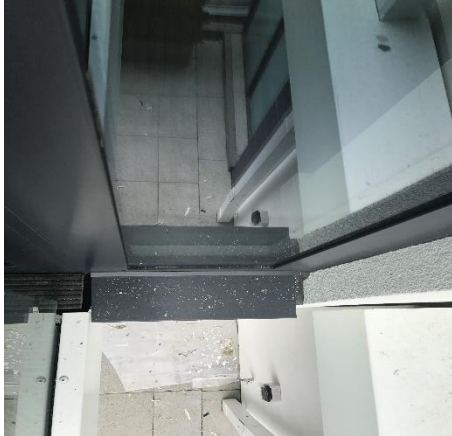
- Untidy door silicone seals (external).
- Why welded metal balcony parapet tops on front balcony but not on the back?
- Silicone smears in corner of metalwork to balcony.
- Light scratching to glass.
