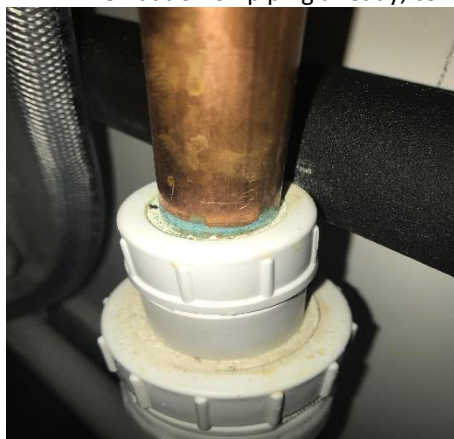
- Pencil marks on walls still around and above pipes.
- Poor finish around plumbing behind washing machine.
- Oxidation on piping already; consider reason and longevity implications.
